Forensic engineering MPB Eindhoven Airport in Structures Laboratory Eindhoven

Eindhoven Airport

By: Simon Wijte

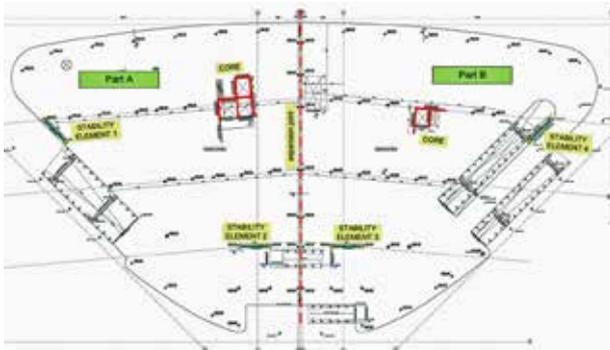
Figure 1: Structural plan

The building of the MPB is consists of two almost symmetrical parts, which are separated by an expansion joint (Figure 1). The four layer concrete structure is created by flat slabs, columns, and three bracing elements in each part. The flat slabs are constructed with a so called BubbleDeck floor, that is created by precast concrete planks with a thickness of 70 millimeters on which weight-saving bubbles with a diameter of 360 millimeters are placed. On site, the construction of the floor is finalized with a layer in situ concrete of 380 millimeters.

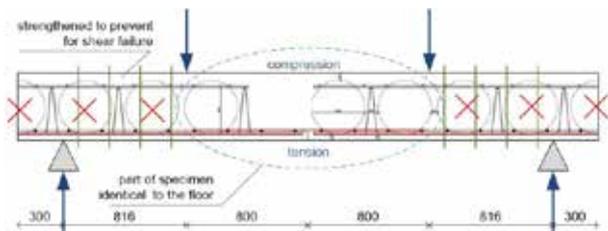
Figure 3: Specimen in the four-point-bending-test

In the experimental research, a four-point-bending-test was performed (Figure 3). In the middle of the specimen, a large moment is achieved while the shear force is limited. The specimens, with a width of 0.8 meters, were sawn from the constructed floors. In total, ten specimens were available. Four of these have been tested when the compressive strength

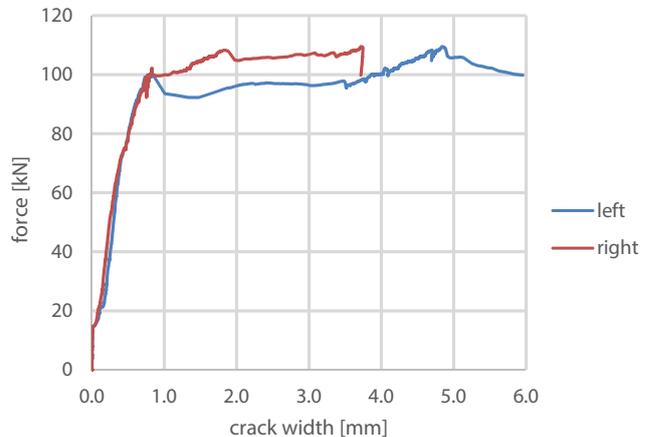
Figure 4: Specimen KL18 relations between load displacement and load-crack width at the interface

The load on the specimen could be increased up to 100 kN with a slight increase of deflection. After that, the deflection increased rapidly while the force could be increased marginal. During the test, a crack occurred in the interface between the plank and the in situ concrete. Also, the width of the seam between the two planks increased with an increase of load. The width of the crack at the interface was measured. It could be noted that the crack appeared already with a limited load. At the point where the deflections started to increase rapidly, also the width and the length of the crack at the interface increased rapidly. In the failed specimens, the crack in the interface continued over the length of the coupling reinforcement and after that continued in a vertical direction (Figure 5).

previous test with the limited concrete strength. The same failure mechanism was found and also the failure load did not vary. Therefore, it is concluded that the compressive strength of the in situ concrete does not influence the failure load. A summary of the test results is given in *Table 2*.

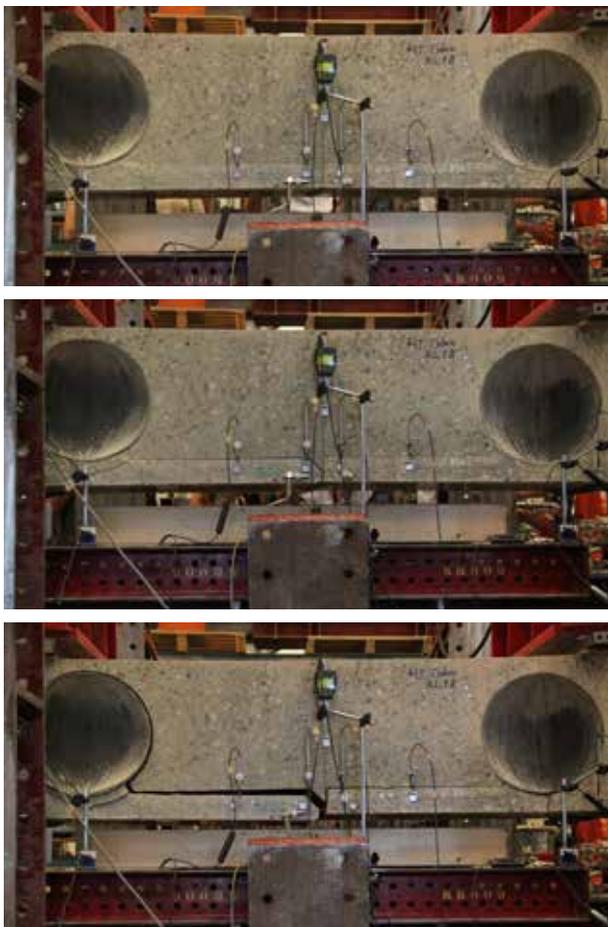
Figure 5: Failure mechanism of the test specimen

With the limited strength for the in situ concrete in all four specimens, failure occurred due to failure of the interface between the precast plank and the in situ concrete. The way the reinforcement was placed, the amount of coupling reinforcement, the presence of a bubble close to the seam, and a chamfer at the seam, seems not to influence the failure mechanism.

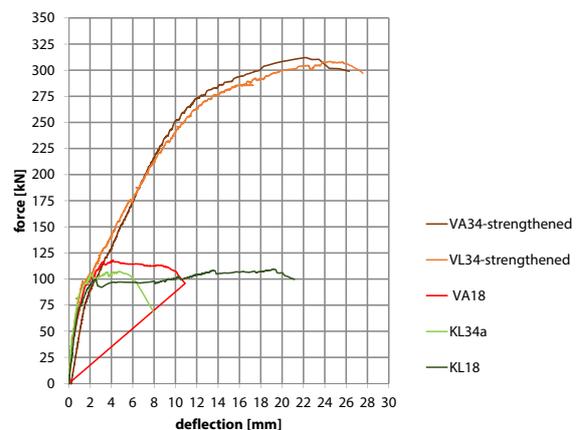
Figure 6: Comparison of the load-deflection behavior of strengthened and regular specimens

Both strengthening measures were successful. With the strengthening measures it was possible to reach the expected failure load and failure mechanism: being the rupture of the tension reinforcement. A comparison of the load-deflection behavior of some regular specimens and two strengthened specimens is given in *Figure 6*.

After seven tests where performed, the focus of the experimental research shifted to the question whether it is possible to strengthen the detail. Therefore, the three remaining specimens where strengthened with threaded studs. These studs were applied in the anchorage zone of the coupling reinforcement and prestressed and anchored with plates and nuts at the top and the bottom. In other specimens, injectable adhesive anchors were applied from the bottom and anchored in the in situ concrete.
