Dealing with residential areas in hazard zones

# Avalanche mitigation measures

By: Stefan Margreth

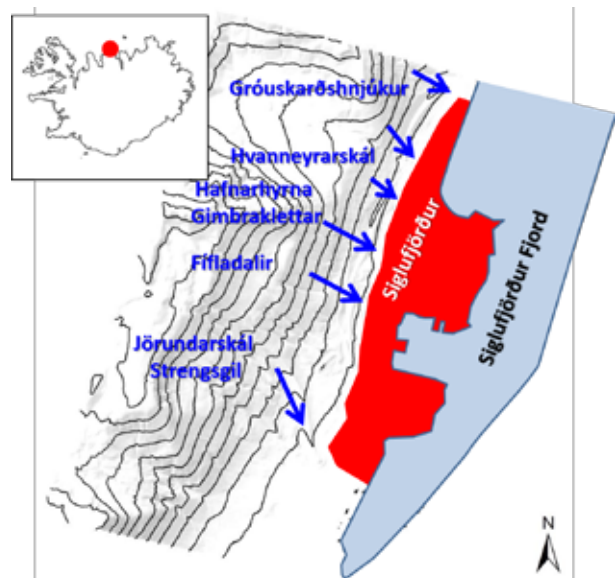
Figure 1: Map of Siglufjörður with avalanche paths

The avalanche situation of Siglufjörður in northern Iceland is unique because the residential area is located directly at the base of several large avalanche paths (Figure 1). Due to the topographical situation, large deflecting or catching dams cannot be constructed without the removal of

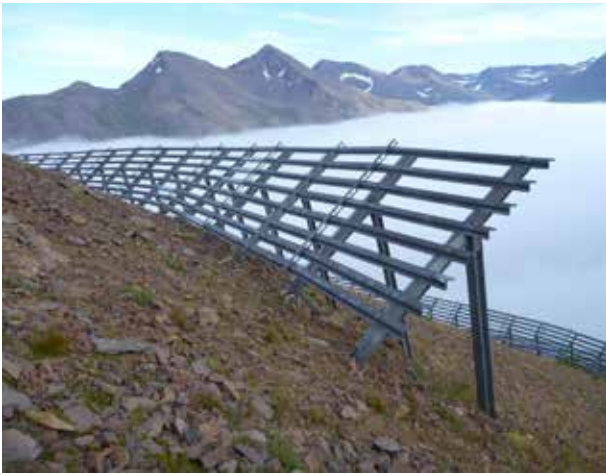
Figure 2: Steel bridges in the release area Gróus-karðshnjúkur built in 2004. The structural height is 3.5 meters and the length of the cross-beams is 4 meters

The protection plan of Siglufjörður is a good example of how comprehensive avalanche mitigation measures can reduce a high risk situation. The combination of supporting structures (Figure 2), and avalanche dams (Figure 3), provides an optimized protection for the town. An important point was to plan the mitigation measures proactively, instead of reacting only after a disaster. The chosen approach with regard to the planning of snow supporting structures with the initiation of snow depth measurements in the release area and with the installation of test structures could be adopted in other mountain regions as well. The participation of landscape architects in the dam design was essential for the acceptance of this large scale project by the community. The application of precise snow depth maps prepared by lidar technology proved to be very helpful for choosing the structural heights.

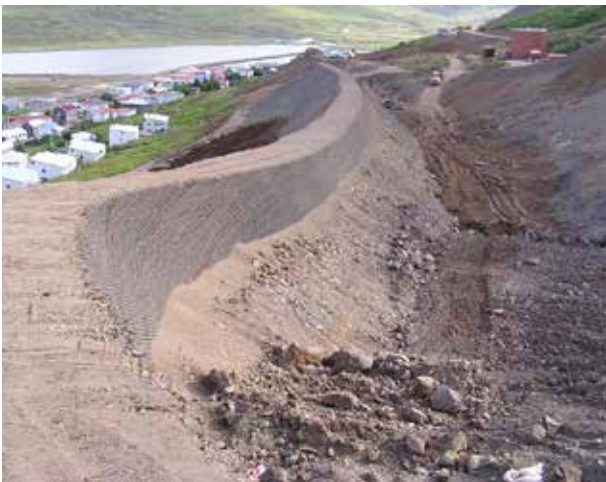
Figure 3: Catching dam in construction: the steep top section is made of geocells

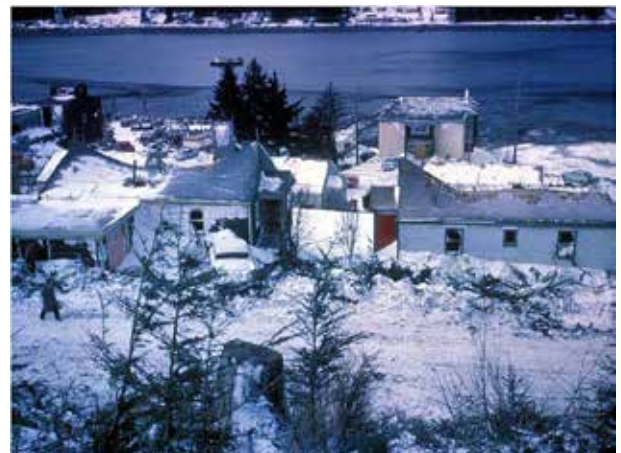
Figure 4: View of Behrends Avenue with Gastineau Channel in the background after the 1962 avalanche: collapsed roofs because of overpressure and impacts of trees. The back-walls are not damaged

Juneau, Alaska's state capital, has a serious avalanche problem. The last major avalanche event in 1962 (Figure 4), was the catalyst for the first proposition of avalanche mitigation measures. In 1972, a comprehensive geophysical hazard study was performed where avalanche hazard zones were suggested. The zones were re-evaluated in 1992. In 2011, the SLF was mandated to investigate mitigation measures to decrease the avalanche risk in the two most dangerous avalanche paths. Besides structural mitigation measures, such as snow supporting structures or earth dams, the application of fixed installed remote-controlled exploders was investigated as well. The buyout of homes seems to be one way to effectively reduce the avalanche risk on the long-term. Currently, the only avalanche safety measures consist of an avalanche response plan, information and training for residents and responders, and an avalanche forecasting program.

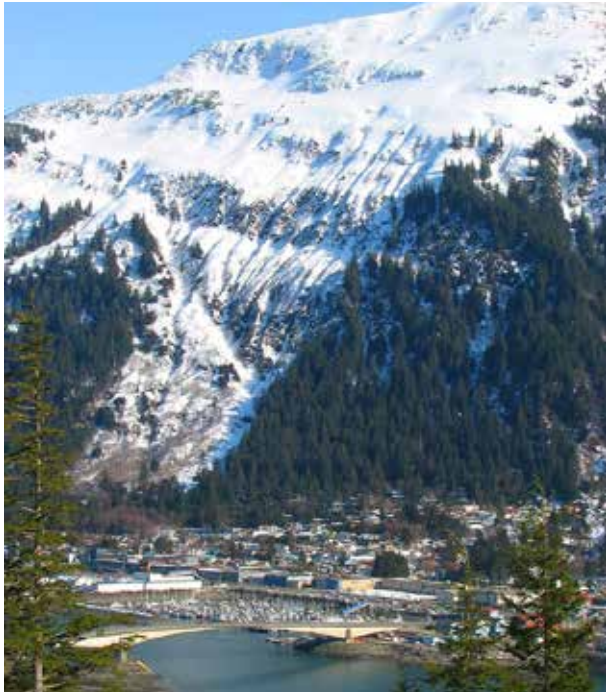
Figure 5: Overview of Behrends Avenue path

The avalanche problem is very serious in the runout zone of Behrends Avenue avalanche path (Figure 5). According to current standards, the risk is far beyond an acceptable level. The unacceptable risk to the residents in the hazard zones can be managed only on short term if the City and Borough of Juneau would order evacuations and close endangered areas during periods of high avalanche danger. Since the buildings in the hazard zones have no structural reinforcement, people inside these buildings are not safe. Continuing with the established avalanche hazard evaluation and forecasting service in the community during the winter months is recommended and is a very good starting point to develop an evacuation concept. Moreover, the education and awareness to the public about avalanches is valuable. While this is improving the situation, these measures are not sufficient with respect to the serious avalanche problem. The reduction of the avalanche risk with structural protection measures is prohibitively expensive and therefore not recommended. Furthermore, the artificial release of avalanches is not advisable, mainly because of the danger to people, property, and homes. The buyout of endangered homes in the avalanche path by the government is the only way to effectively reduce avalanche risk on the long term.
