Renovation of the Binnenhof

The complex task of modernizing a historic landmark

By: **ir. Anne Derks & Earnest Alderliesten**

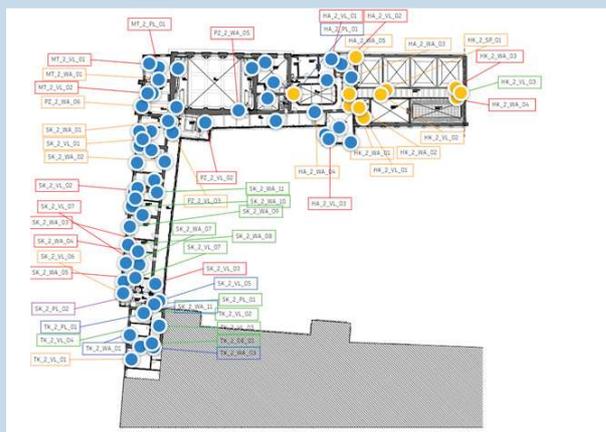
1. Performing a research in the BIM360 environment, in which the location and research needs are defined.
2. Carrying out and documenting the research by the contractor in collaboration with consultants. Results and photos can be added directly from a tablet.
3. Processing the results in the design models by the design team, with a link to the research number of the element in question.

Figure 1: BIM360 environment research phase

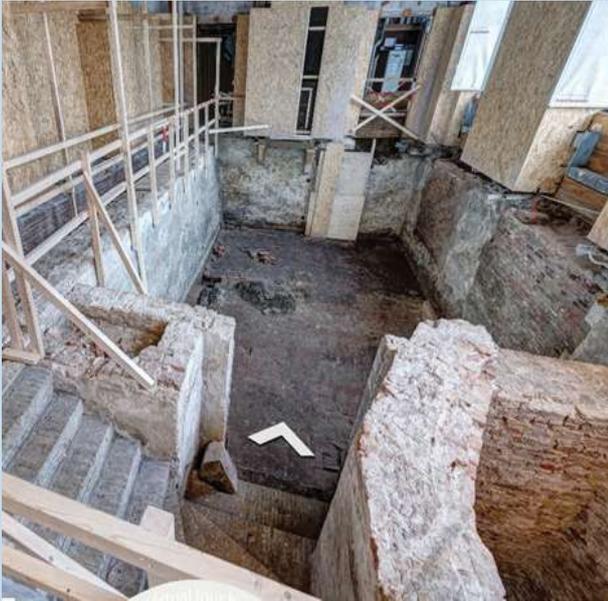
During the investigations, several (archeological) discoveries were made, which impacted the design. For example, a retaining wall from the late 13th or early 14th century was discovered in the 'Volle Raadzaal' of the Raad van State (Figure 2). Additionally, a basement from the early 16th or early 17th century was found here. The retaining wall was a fascinating observation since it was preserved entirely in the ground despite its size and depth below ground.

Figure 2: Discovered basement Raad van State

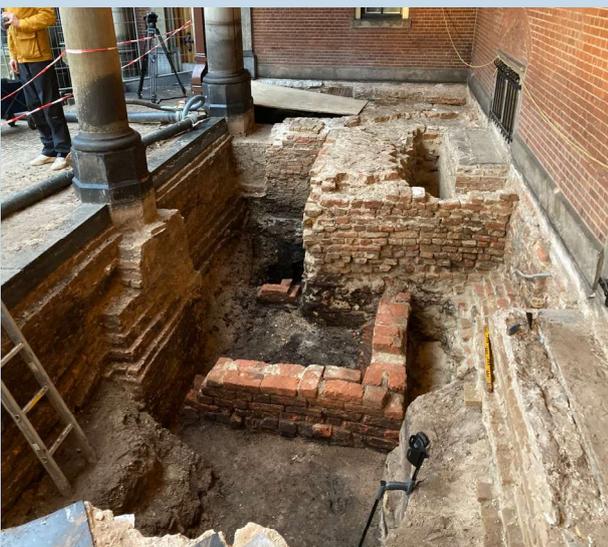
In addition, archaeologists have found foundations from the 13th century under the gallery of the Eerste Kamer. According to the archaeologists (Figure 3), these are remains of an unknown building from the period of Count Floris the Fifth.

Figure 3: Discovered foundations under gallery Eerste Kamer

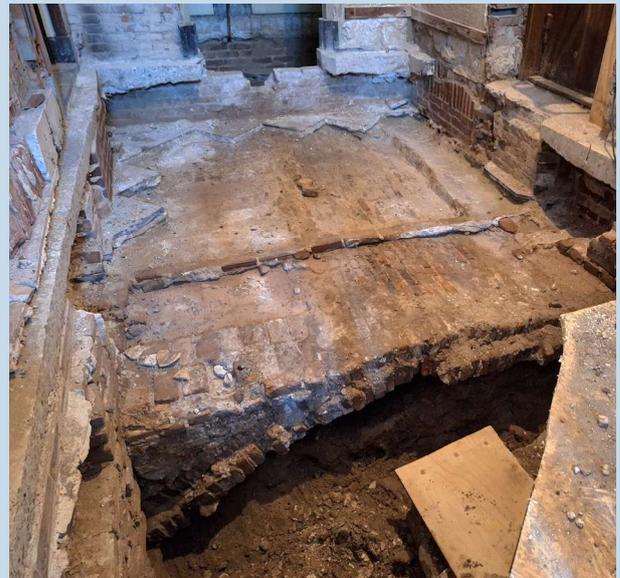
Currently, an investigation is going on at the base of the stairwell of the Raad van State (Figure 4). While excavating, a floor and multiple beams of natural stone were found. Further excavation revealed a monumental marble floor

Figure 4: Archeological found during excavation stairwell Raad van State

as well. Both floors were carefully removed and stored. After these floors were removed, a vault was found with a layer of sand underneath. Excavation has been halted to facilitate archaeological research on this vault.

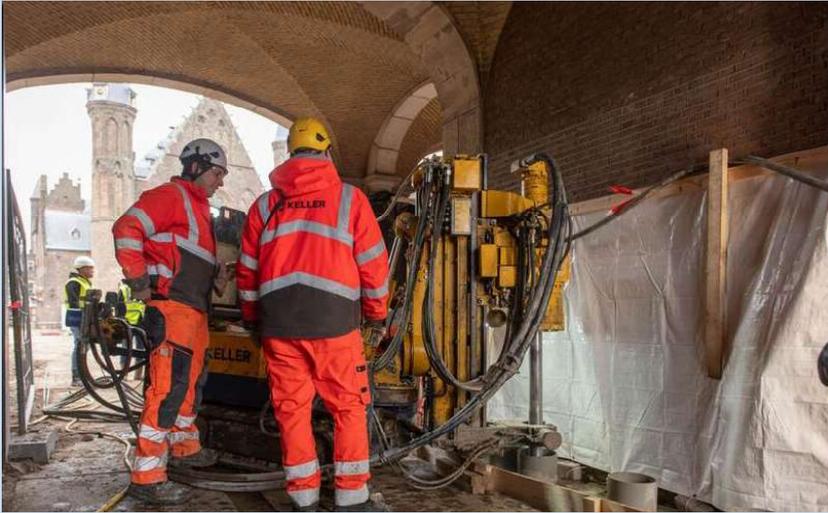
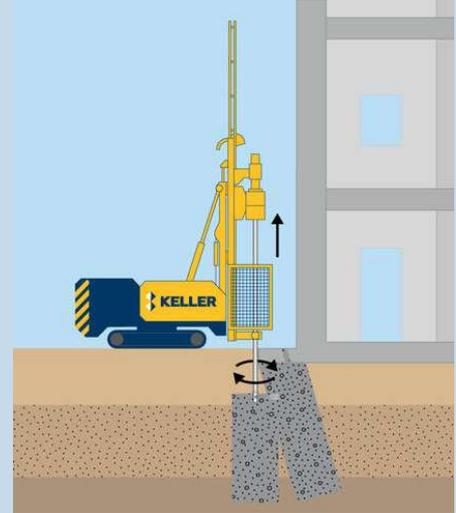
To determine whether lowering of the ground level was possible, foundation research was conducted. It was found that the foundation of one side of the gate was not deep enough to lower the ground level without additional measures. The foundation was reinforced with jet grouting columns (Figure 5). Jet grouting is a technique where a steel pipe with a nozzle goes into the ground. High-pressure grout (a mixture of cement and water) is then injected into the ground. The grout mixes with the soil, creating a soil-cement mass. After hardening, a hard block is formed, which is used as an additional foundation. The firm Keller constructed a wall of Soilcrete®-slats underneath the existing foundation until the desired depth to reinforce the foundation.

Figure 5: Jet grouting Stadhouderspoort (Binnenhof Renovatie, 2024) & (Keller, n.d.)

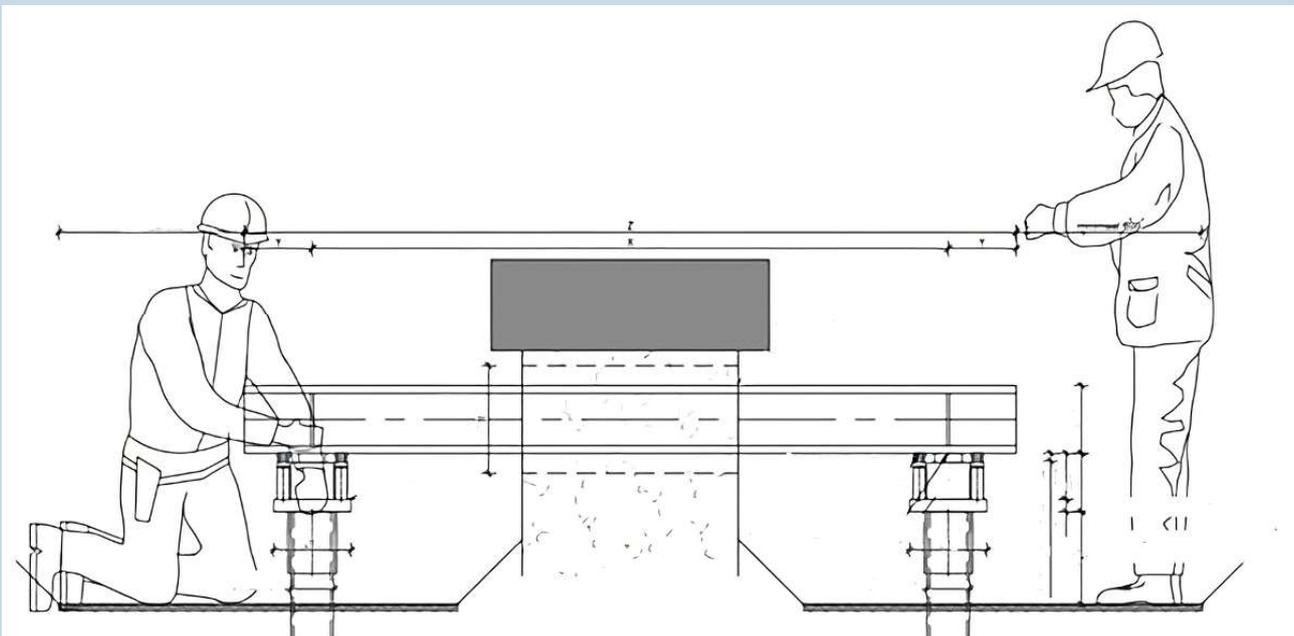
the arches. As a precaution and to prevent damage, these foundations are temporarily reinforced with two screw injection piles and hydraulic jacks (Figure 5). With these hydraulic jacks, it is possible to adjust the footings if settlements occur.

Installing the piles posed a challenge as they had to be constructed using a tiny crane, given that the arches were too low for a larger one. After the installation of the piles, a horizontal hole was made in the footing. In this hole, a beam was placed, supported by the two jacks on the piles. The jacks can be adjusted in height during the construction phase if settlements occur. Finally, the hole in the footings was poured with mortar. During the application of the jacks, temporary structures supported the arches.

Figure 6: Temporary foundation reinforcement with hydraulic jacks
