Forensic engineering MPB Eindhoven Airport in Structures Laboratory Eindhoven

Eindhoven Airport

By: Simon Wijte

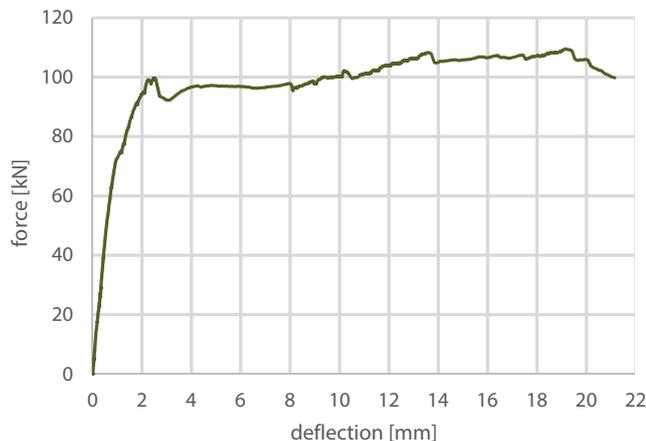
Figure 3: Specimen in the four-point-bending-test

In the experimental research, a four-point-bending-test was performed (Figure 3). In the middle of the specimen, a large moment is achieved while the shear force is limited. The specimens, with a width of 0.8 meters, were sawn from the constructed floors. In total, ten specimens were available. Four of these have been tested when the compressive strength

of the in situ concrete which was limited to approximately 20 N/mm². The behavior of these four specimens was kind of similar.

The load on the specimen could be increased up to 100 kN with a slight increase of deflection. After that, the deflection increased rapidly while the force could be increased marginal. During the test, a crack occurred in the interface between the plank and the in situ concrete. Also, the width of the seam between the two planks increased with an increase of load. The width of the crack at the interface was measured. It could be noted that the crack appeared already with a limited load. At the point where the deflections started to increase rapidly, also the width and the length of the crack at the interface increased rapidly. In the failed specimens, the crack in the interface continued over the length of the coupling reinforcement and after that continued in a vertical direction (Figure 5).

With the limited strength for the in situ concrete in all four specimens, failure occurred due to failure of the interface between the precast plank and the in situ concrete. The way the reinforcement was placed, the amount of coupling reinforcement, the presence of a bubble close to the seam, and a chamfer at the seam, seems not to influence the failure mechanism.
